## **Analysis of the Destructive Winds in the Tallong/South Marulan region on December 1, 2020**

Destructive winds occurred over the Tallong/South Marulan regions on December 1, 2020 which caused considerable damage and loss of power. In this report there will be an analysis of the observed meteorology, photographic evidence of the damage and a preliminary interpretation of the possible causes.

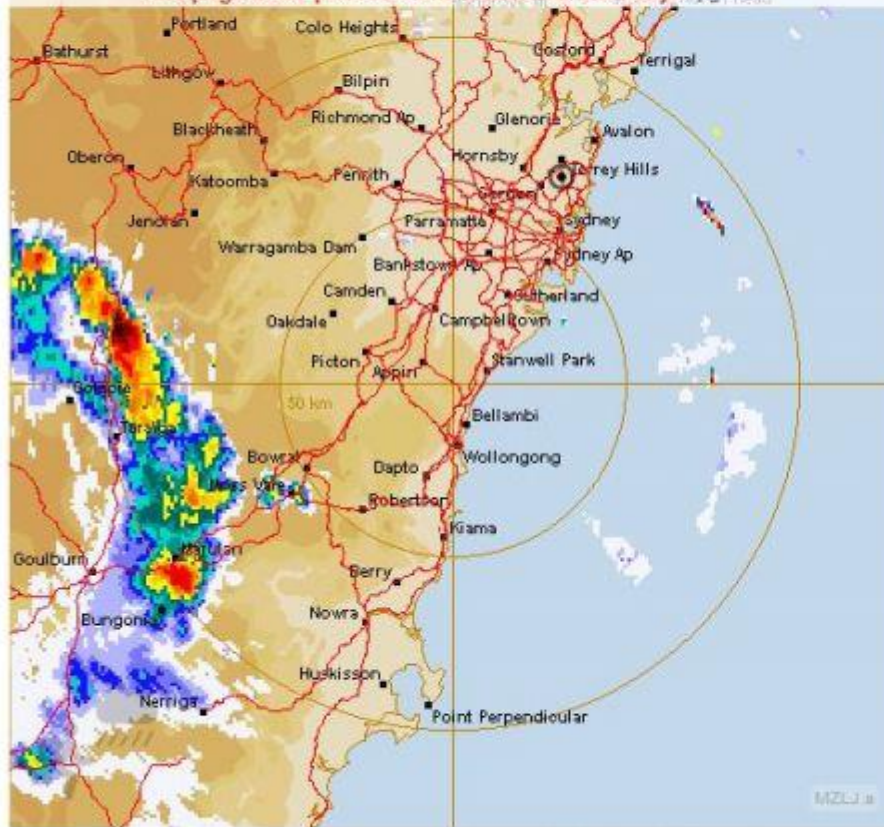
Other data are available from the Bureau of Meteorology weather radar observations. In Figure 3 the rain radar image at 1704 AEDT (1604 AEST) shows a patch of intense precipitation over the Tallong/Marulan area. In fact during this event the rain was of short duration with typical 10-15 minute amounts of only 0.8-8.5 mm. The Doppler wind radar image taken at 1704 AEDT is seen in Figure 4. In this case there is a line of intense wind speeds near the extreme scale of 90 km/hr towards the radar (dark blue shading) following the line of the rain patterns in Figure 3. An animated sequence of both the rainfall and Doppler radar images during this event (from Weatherzone) will be available on the TCFG website under the Weather Menu.

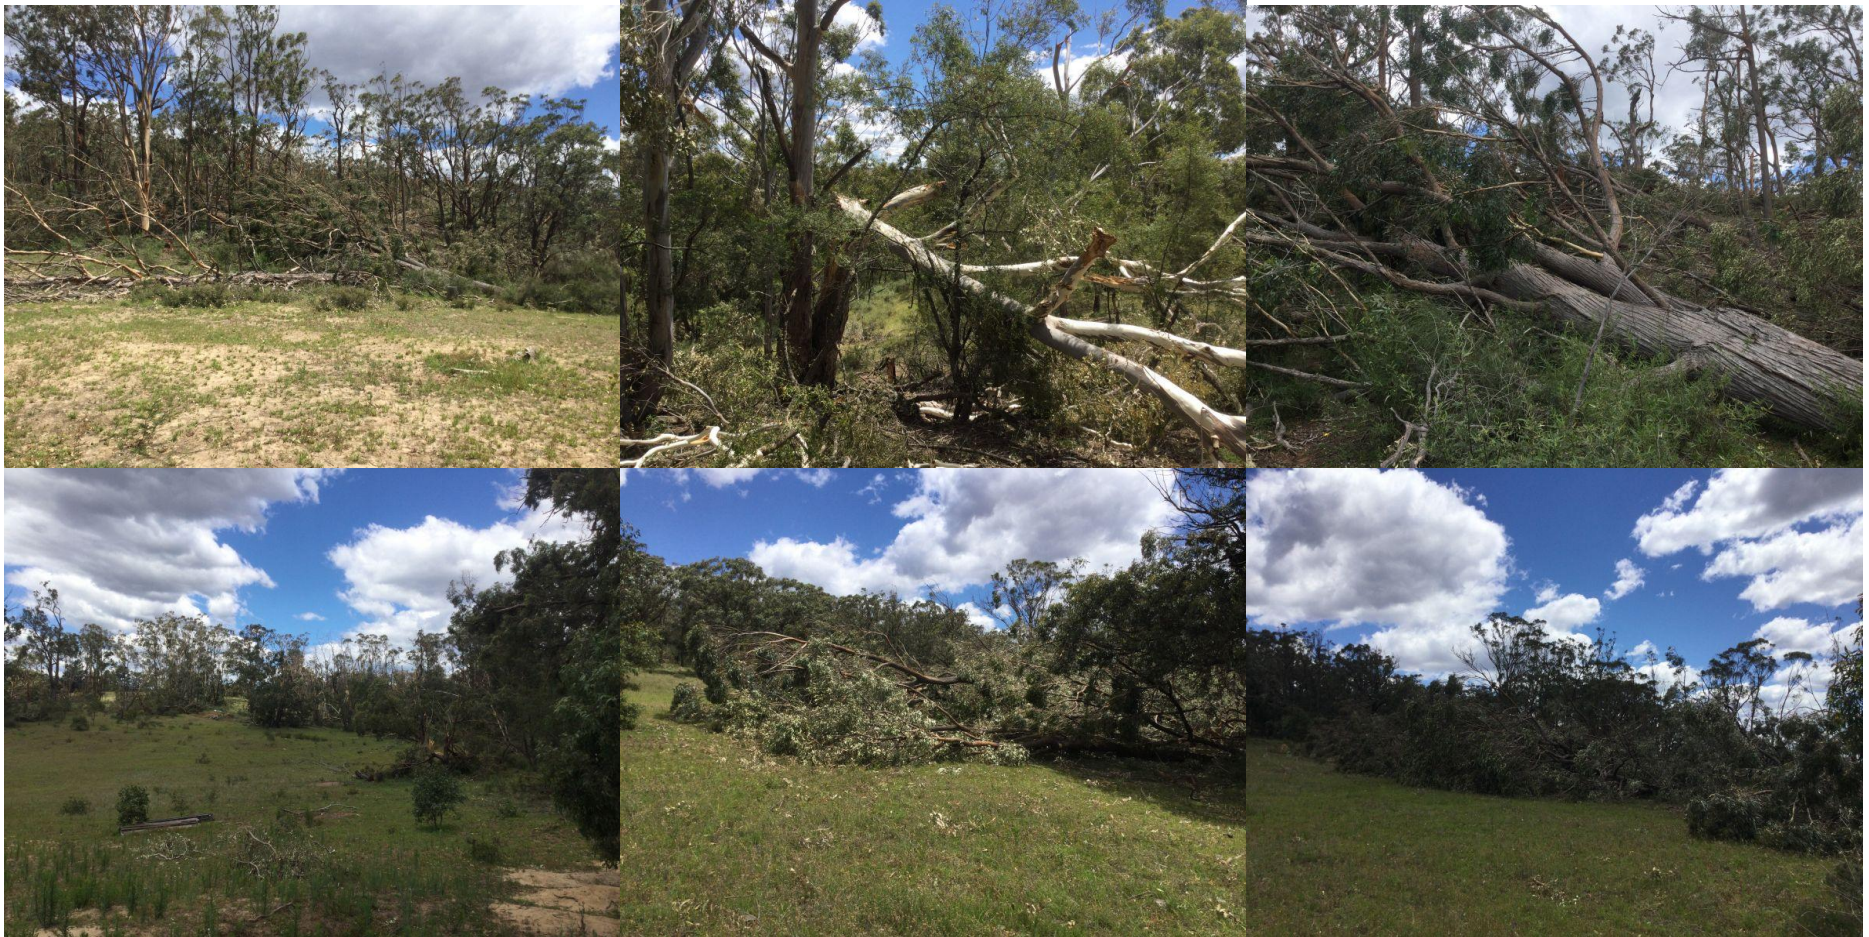
There was extensive damage across the Tallong/Marulan region in the form of thousands of large trees (mainly eucalypts) being uprooted, snapped off and twisted and power lines brought down with significant electricity outages. Great swathes of trees were knocked down at the end of Longpoint Road, Tallong and into the entrance of Morton National Park (MNP) there. Some of the tree damage on the farm at 432 Longpoint Road can be seen in Figure 5. These images were taken of about a 100m wide path of tree destruction through a forest on the farm bordering the MNP. Not only were trees snapped but huge gum trees uprooted. Elsewhere on the farm and across Longpoint Road there were other significant tree uprootings (Figure 6). Inside the MNP to the left of the entrance can also be seen trees snapped half way up and a tree trunk twisted and bent (Figure 7). Further SW on Greenhills Road, Marulan there was also evidence of trees being snapped and forest destruction (Figure 8). The overall impression is of small areas of intense destruction.

exceeding 100 mph." (NSSL 2021). In Figure 12 from this report there is an overseas example of forest destruction due to a microburst. It is suggested that the tree destructions in Figure 5 and Figures 9-11 are similar to that in Figure 12. Johnson (2018) reported " Microbursts are often mistaken for tornadoes as both can have damaging winds, a loud "roaring sound" from high winds, and "twisted" off tree damage."If it's a tornado, that damage is going to be in different directions. For a microburst wind, chances are everything is going to be in the same direction, so trees are going to be laying down in the same direction," said Chief Meteorologist Chris Bailey." The observation of possible "twisting" associated with a microburst is consistent with the observations in Figure 7 and trees lying in the same direction consistent again with Figure 5 and Figures 9-11. Other reports on microbursts can be seen at Pedersen (2016) and Caracena (1994). Geerts (2000) studied a climatology of strong short-lived wind gusts (microbursts) in NSW and found that above 21 ms<sup>-1</sup> the frequency of occurrence fell by 50% in each 3 ms<sup>-1</sup> increment.

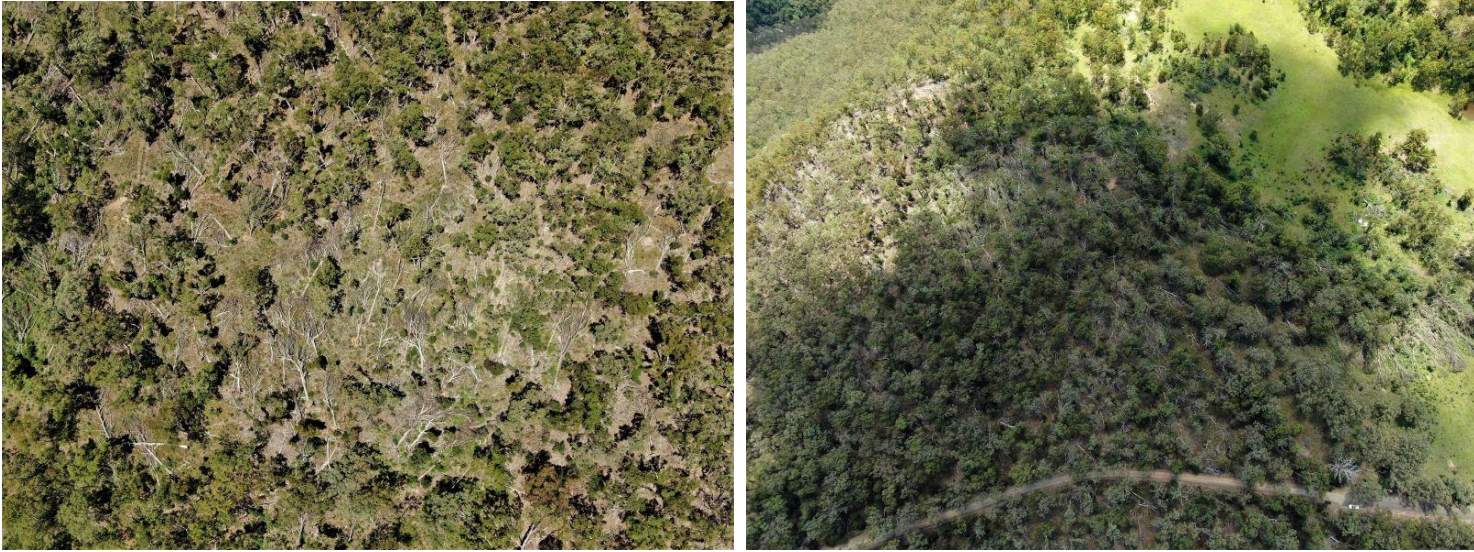
**Figure 9**

Drone photos on the Longpoint Rd farm taken some 13 months after this destructive event show consistent directions of the tree downfalls. These can be seen in Figures 9-11. A drone flyover of the affected area near the end of the bitumen section of Longpoint Road can be seen at <https://youtu.be/QuGkKW9sISY>
